Tabor East Apartments

7298 SE Division St.

Project Summary

Overview of the Stormwater System

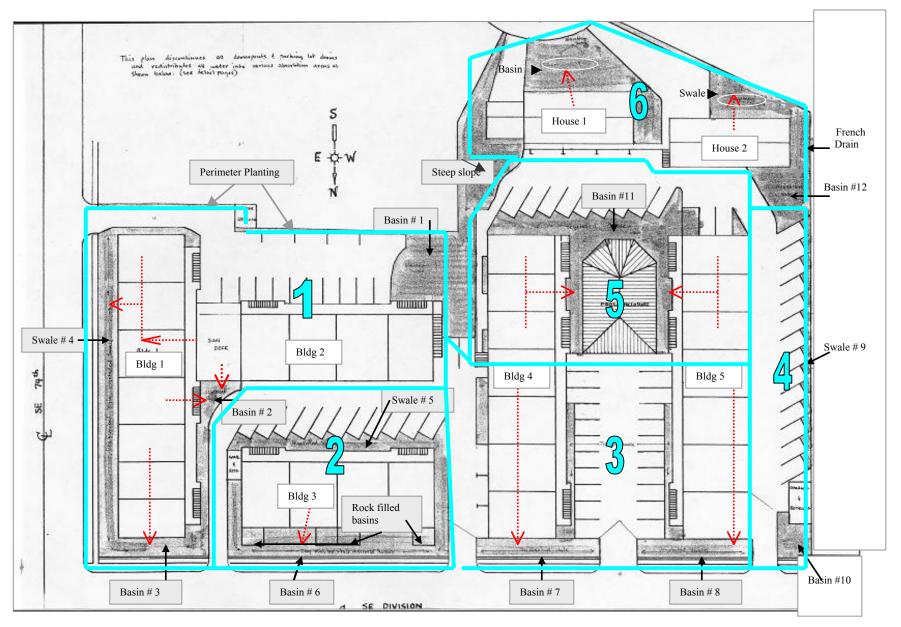
Figure 1. Plan of the apartment complex with the locations of the stormwater management facilities. The red arrows indicate the direction of travel for runoff from the roofs.

- The apartment complex is divided into 6 sub-catchments (see Figure 1).
- Most of the sub-catchments drain to a system of linked swales and basins along the edges of the buildings and parking lots.
- The new system receives runoff from over 26,000 sq. ft. of parking lot and 35,800 sq. ft. of roofs.
- Approximately 7,200 sq. ft. of asphalt was removed to create landscape stormwater facilities. Portions of the existing parking lots were re-graded to direct runoff into the stormwater facilities.
- The second and final phase will be completed in fall 2004.

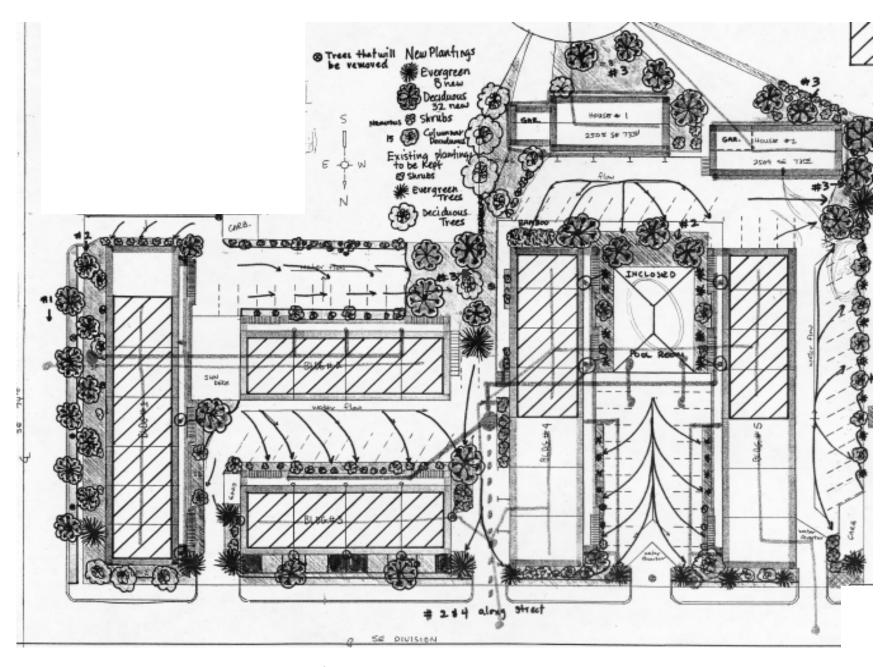
Figure 2. Site Plan of Tabor East Apartment complex indicating flow patterns of parking lots.
